Report

Lake Ettamogah Winter Storage Dam Design Review

29 JANUARY 2014

Prepared for
Norske Skog Paper Mills (Australia) Ltd Albury
Private Bag
Lavington
NSW 2641
43260627

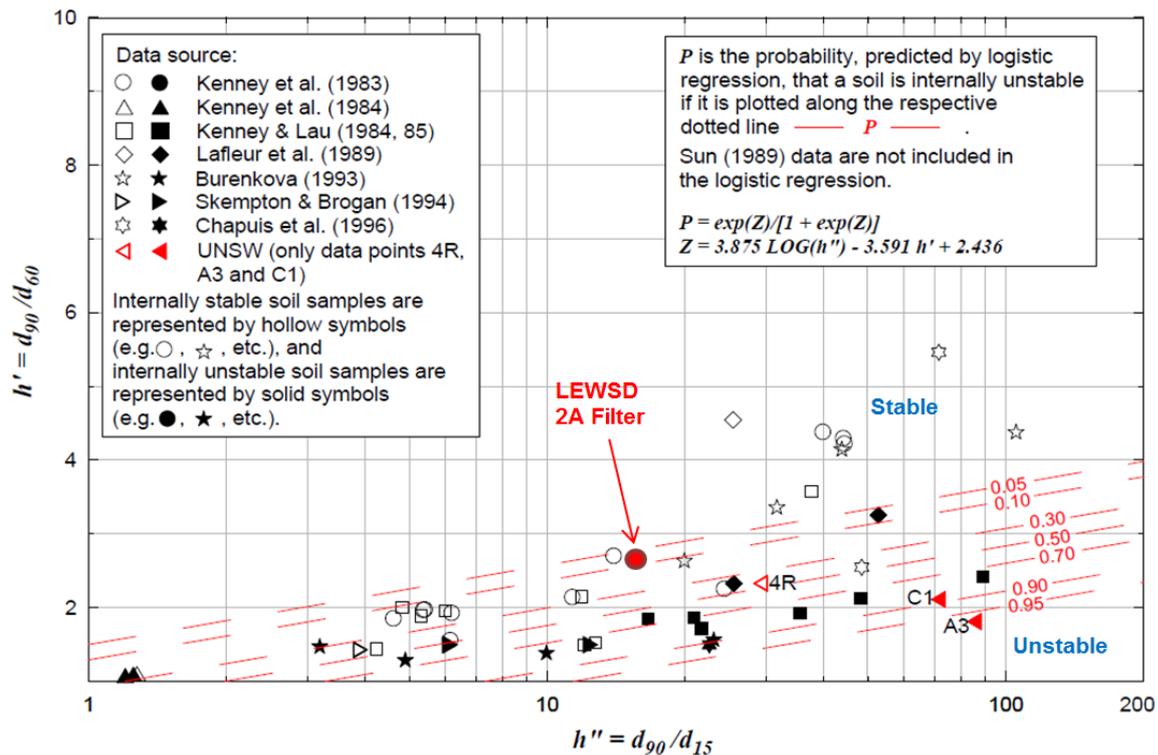
Figure 2-2 Internal Stability Check (<10% non-plastic fine) - Wan and Fell (2004)

Based on this assessment, it is concluded that the Zone 2A filter material is unlikely to experience internal instability/ suffusion and therefore it is acceptable to assess the filter compatibility of the materials without having to adjust for the possible loss of fines associated with suffusion.

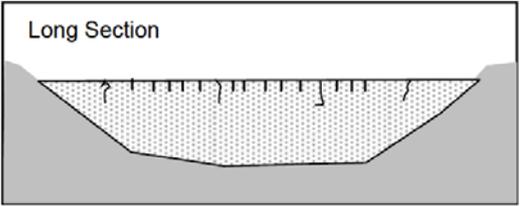
Initiating Mechanism	Sketch
Desiccation cracking

Desiccation Cracking

This initiating mechanism involves drying and shrinking of the earthfill resulting in the development of cracks near the embankment crest. The maximum likely crack depth was assessed to be 3 m below the dam crest and approximately 1 m below FSL. This assessment takes into consideration the following factors in determining the likelihood of crack development:

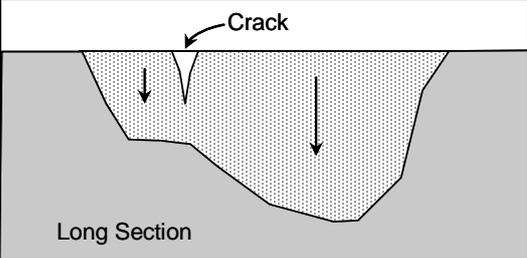
Transverse cracking due to cross valley differential settlement

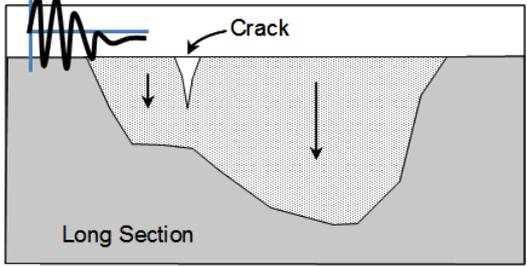
Transverse cracks caused by earthquake

Transverse Cracking Caused by Earthquake

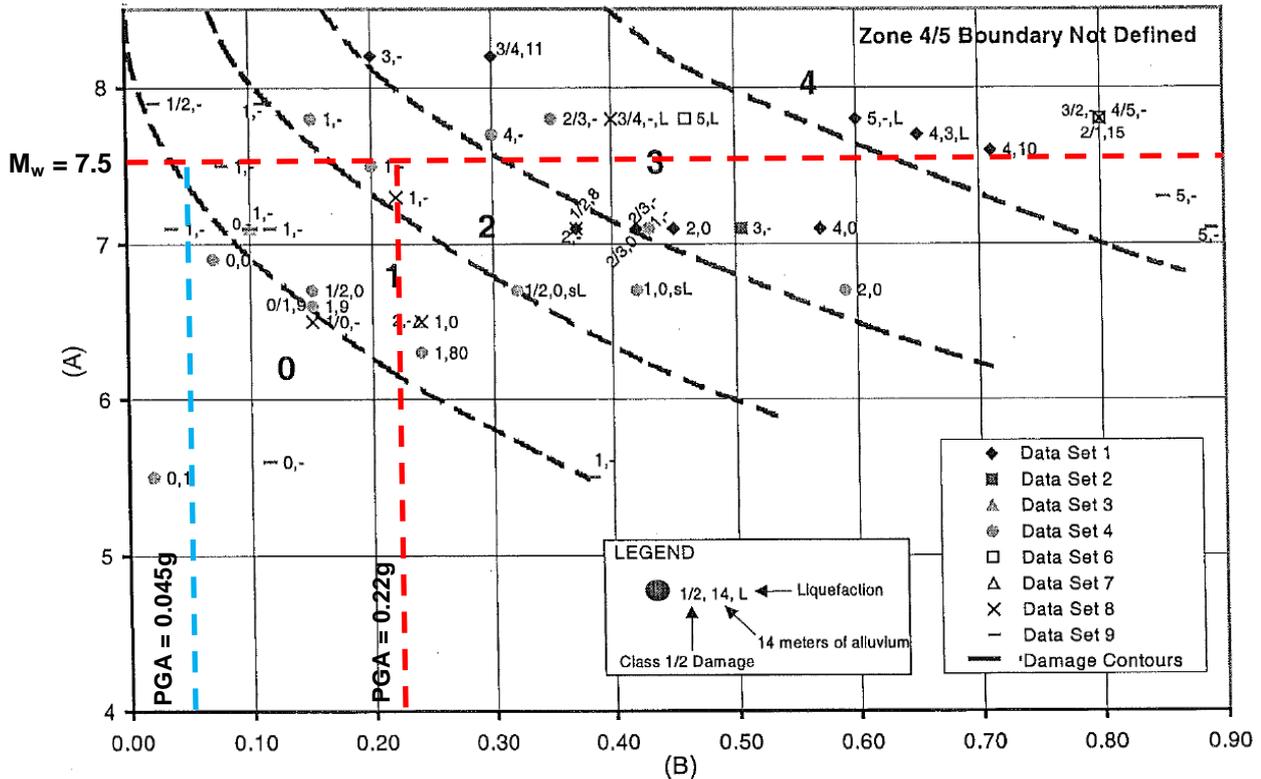
Figure 2-4 LEWSD plotted on Pells & Fell (2002) damage class contours

Figure 2-4 shows the position of LEWSD on the damage class contours, and Figure 2-5 shows the maximum settlement and longitudinal crack widths according to Pells & Fell (2002).

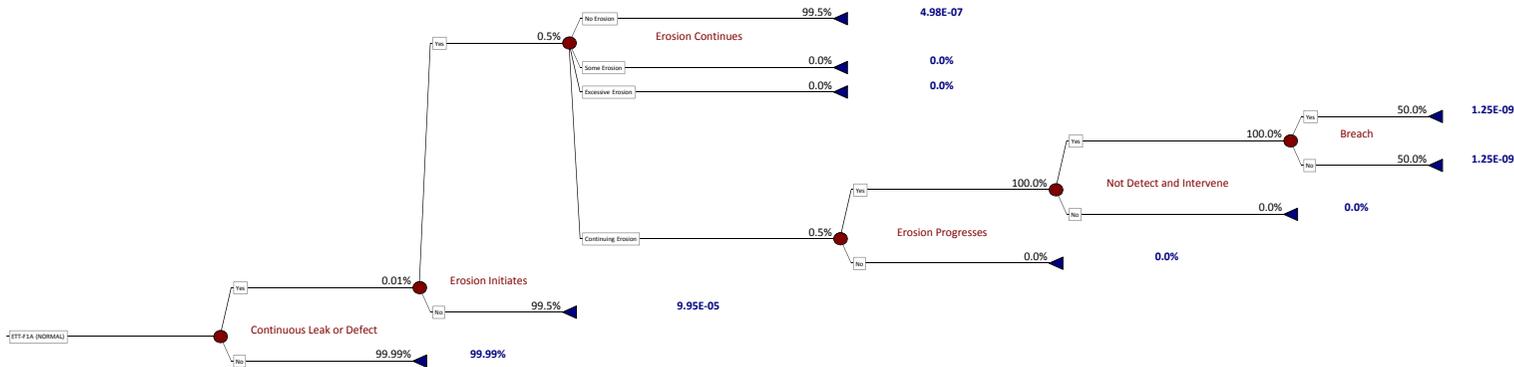
Failure Mode For
 ETT-F1 Piping through embankment Normal & EQ
 ETT-F1a Mechanism Cross valley differential settlement

Continuous leak or defect?	Erosion initiates	Erosion Continues	Erosion Progresses	Not Detect and Intervene	Breach
Uniform and gentle abutment profile	table 5.24 crack at crest = 1mm	Filter exhibits high fines content 6-7% and compacted (assume non-plastic). Table 10.2 adopt Pr continuing erosion = 0.005	Table 11.1 homogeneous embankment of clay to sand clay. Will hold a roof. Pr = 1	Table 12.2 CL-CH, low gradient - rapid erosion	Table 13.3. Defect in upper part of embankment, small storage. Assume reservoir falls below invert of pipe quickly (<1 day). Adopt Pr=0.5
Slopes less than 30 degrees	assume 1mm crack at FSL also		Table 11.2 homogeneous earthfill no crack filling action. Pr = 1	Table 12.3 Likely breach time medium - rapid	
dam less than 15m (13m)	Gradient <0.1		Table 11.3 no flow limitation	Table 12.1 Likely breach time 12-24hrs	
Table 5.1	Table 5.33 adopt Pr = 0.005			Inspections twice weekly. Assume Pr = 0.25 of detecting piping incident i.e. 0.75 that won't

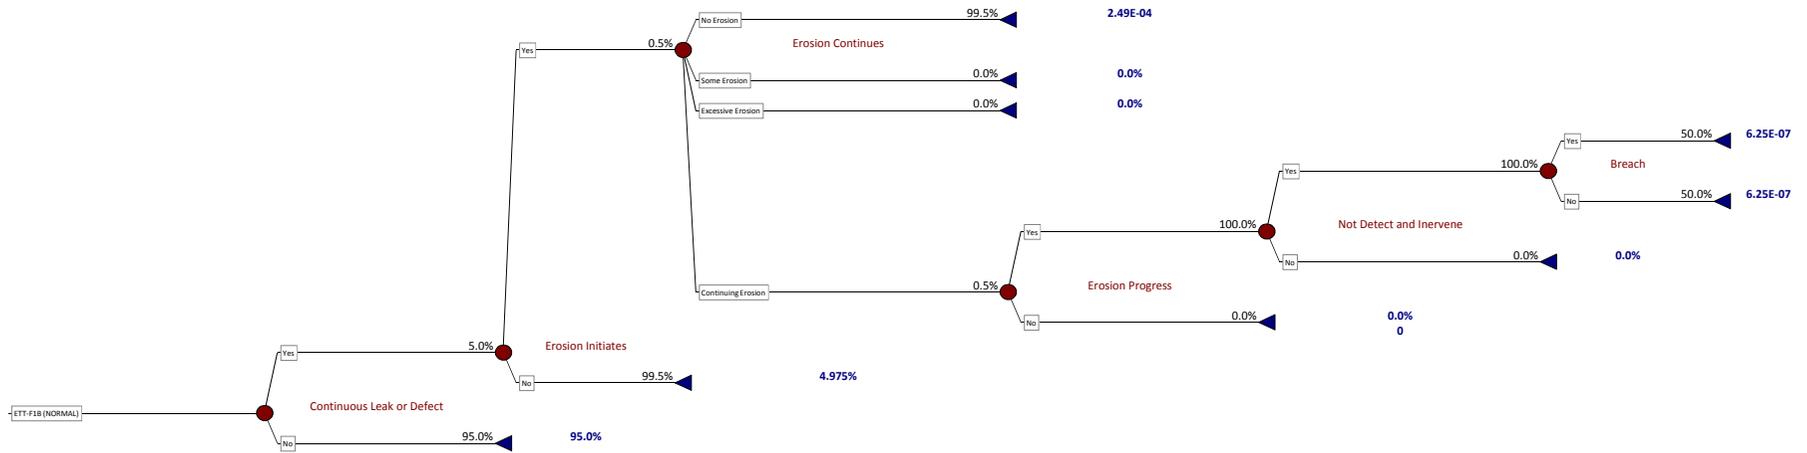
Continuous leak or defect?	Erosion initiates	Erosion Continues	Erosion Progresses	Not Detect and Intervene	Breach
Table 5.11 gravel surface assume to be at least 150mm thick (2) seasonal climate (2)	Table 5.24 - crack width = 20mm @ crest. No cracks observed during inspection however, cracks could be obscured by gravel capping Table 5.25 crack width at FSL 1-2mm Gradient <0.1	Filter exhibits high fines content 6-7% and compacted (assume non-plastic). Table 10.2 adopt Pr continuing erosion = 0.005	Table 11.1 homogenous embankment of clay to sand clay. Will hold a roof. Pr = 1 Table 11.2 homogeneous earthfill no crack filling action. Pr = 1 Table 11.3 no flow limitation	Table 12.2 CL-CH, low gradient - rapid erosion Table 12.3 Likely breach time medium - rapid Table 12.1 Likely breach time 12-24hrs	Table 13.3. Defect in upper part of embankment, small storage. Assume reservoir falls below invert of pipe quickly (<1 day). Adopt Pr =0.5

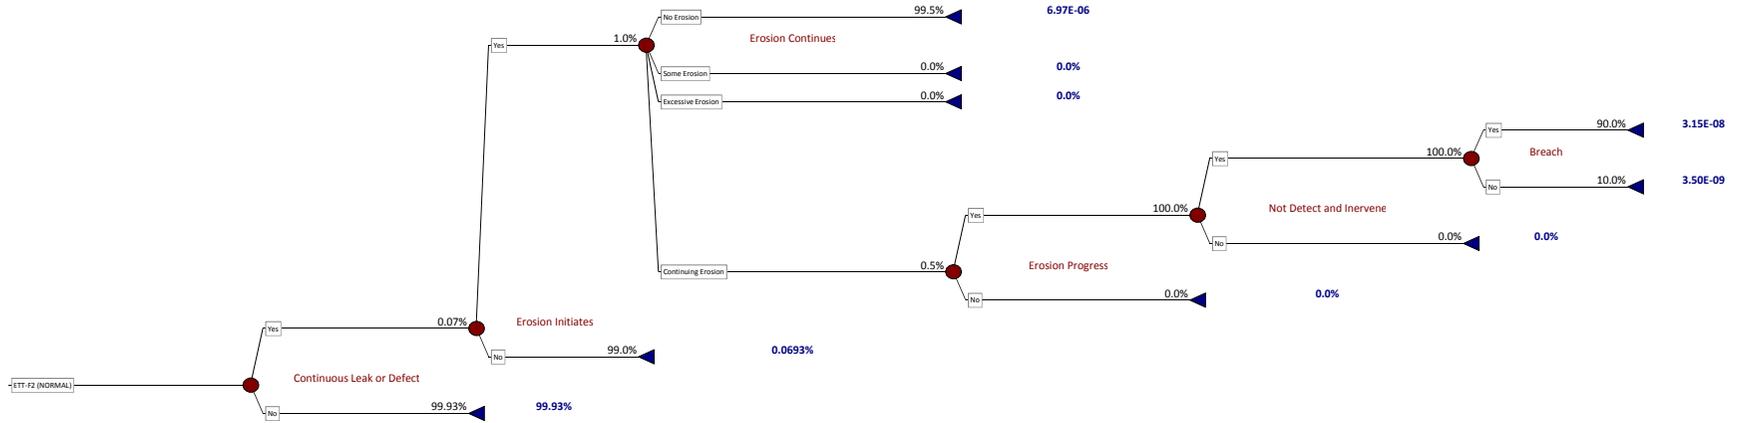
Continuous leak or defect?	Erosion initiates	Erosion Continues	Erosion Progresses	Not Detect and Intervene	Breach
Table 6.11	Table 6.29	Filter exhibits high fines content 6-7% and compacted (assume non-plastic). Table 10.2 adopt Pr continuing erosion = 0.005	Table 11.1 homogenous embankment of clay to sand clay. Will hold a roof. Pr = 1	Table 12.2 CL-CH, low gradient - rapid erosion	Table 13.3. Defect in lower part of embankment. Assume reservoir will not fall below pipe. Adopt Pr = 0.9
concrete encased pipe with vertical sides (2)	spec called for 200mm lifts however assume 300mm was done around conduit.	Well detailed filter diaphragm around conduit	Table 11.2 homogeneous earthfill no crack filling action. Pr = 1	Table 12.3 Likely breach time medium - rapid	
3 cutoff collars at 5m spacing. Cutoff collars shown to not extend above top of encasement so likely reasonable compaction achieved. Also as cutoff collars only in centre part of dam, could likely to have good compaction elsewhere (2)	Good compaction records. Compacted to 98% standard max at 1% dry to 2% wet of optimum moisture content		Table 11.3 no flow limitation	Table 12.1 Likely breach time 12-24hrs

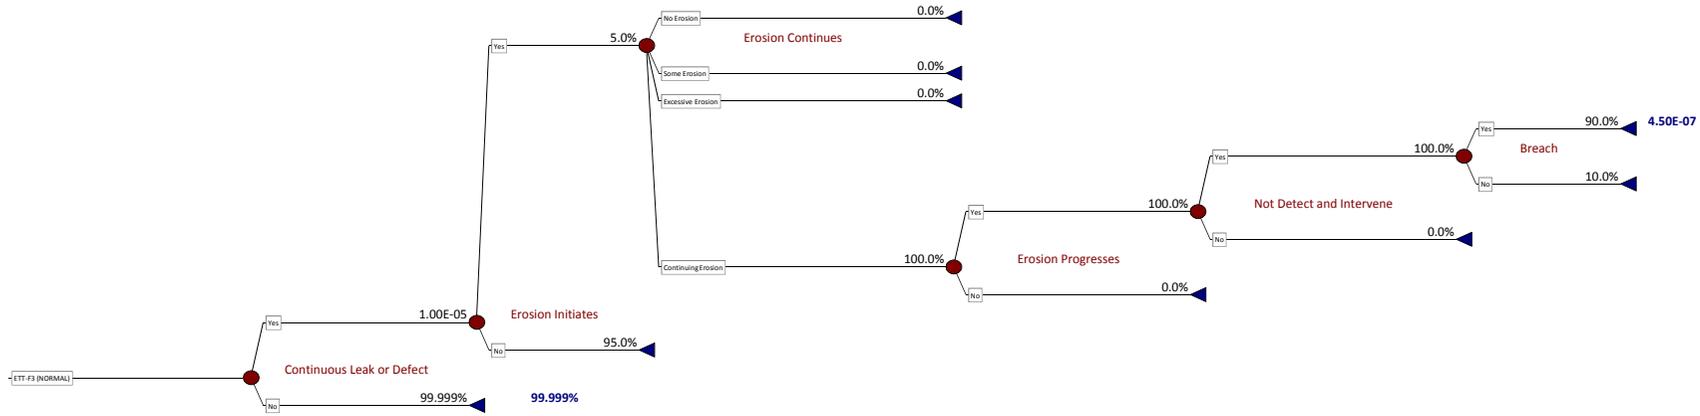
Continuous leak or defect?	Erosion initiates	Erosion Continues	Erosion Progresses	Not Detect and Intervene	Breach
Cutoff understood to be taken to residual soil	assume 1-2mm defect	No filter trench or blanket	Table 11.1 homogenous embankment of clay to sand clay. Will hold a roof. Pr = 1	Table 12.2 CL-CH, low gradient - rapid erosion	Table 13.3. Defect in foundation. Adopt Pr = 0.9
erosion through cutoff considered in erosion through embankment as chimney filter shown in drawings to extend full depth of cutoff.	Residual soil described as sandy clay or clayey sand of low to medium plasticity. Assume foundation is dispersive based on Coffey 1993 encountering more dispersive material beyond 1.5m		Table 11.2 homogeneous earthfill no crack filling action. Pr = 1	Table 12.3 Likely breach time medium - rapid	
erosion through foundation is therefore considered through residual soil described as clayey sand or sandy clay of low to medium plasticity	Table 5.35		Table 11.3 no flow limitation	Table 12.1 Likely breach time 12-24hrs
